Why you should have a galvanic isolator installed on your boat if you are connected to shore power.

by Al Rose

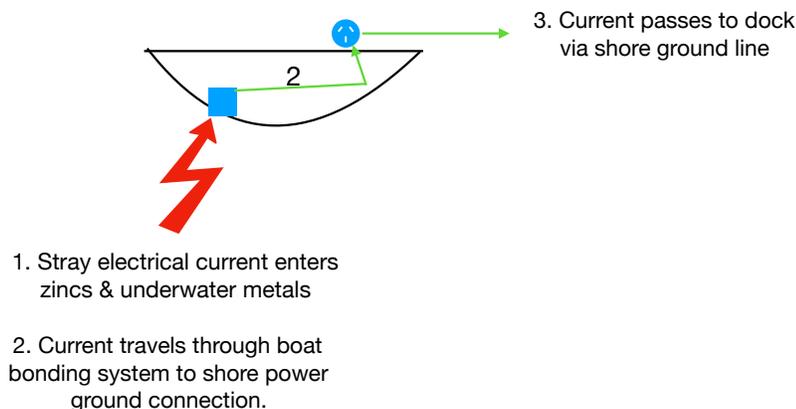
In the simplistic diagram below, is a depiction of stray current path from waters around your boat while dockside. The current will eat away your boat zincs then start to degrade boat metals. To stop this requires a failsafe style galvanic isolator.

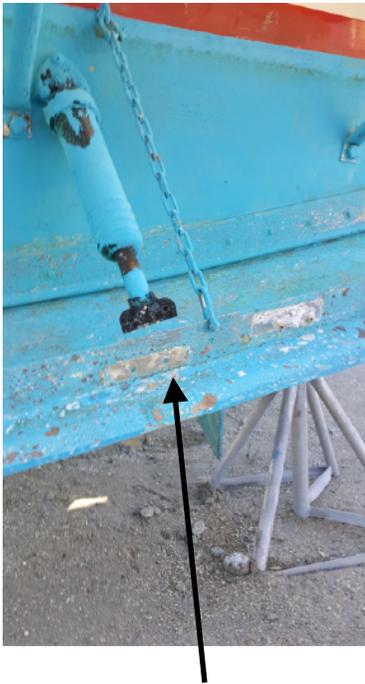
I first noted something wrong when one of my trim vanes became inoperative. Since it was nearing time to pull my boat out for routine maintenance, I waited until my pullout in February to diagnose the cause. In the following pictures, note the closeup of my trim vane. A Bennet trim vane typically has zincs attached using the same bolts that connect the trim vane panel to the hydraulic actuator. When the zincs completely deteriorated, the retainer bolts fell out and the actuator could no longer control the trim vane panel. Stray current at my dock in Newport, RI was the cause.

Left: Bennet trim tab zincs completely eaten away.

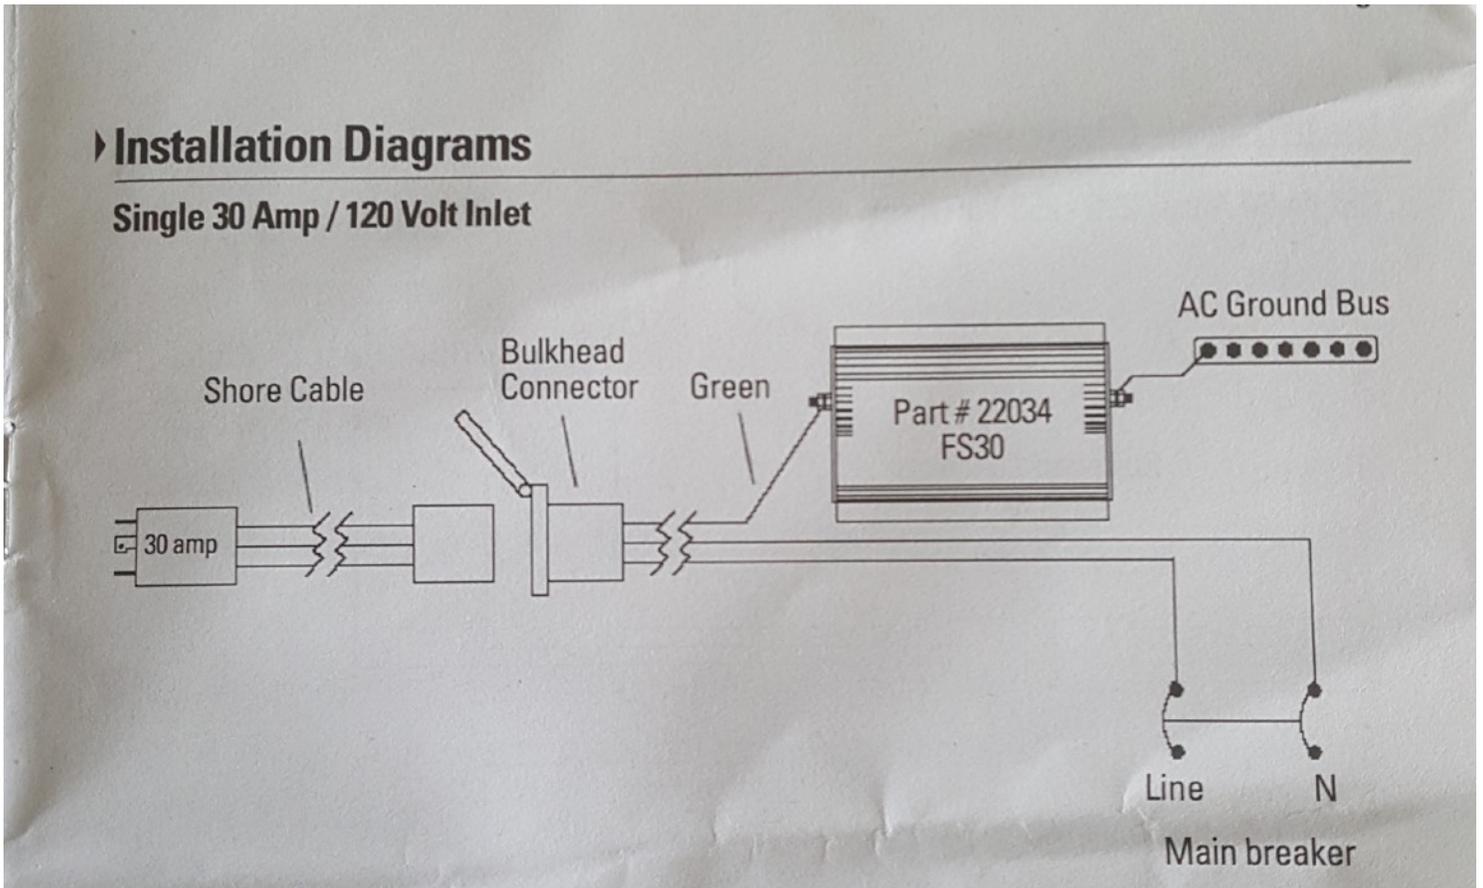
Below: wiring diagram for installation of galvanic isolator in single 30 Amp application.

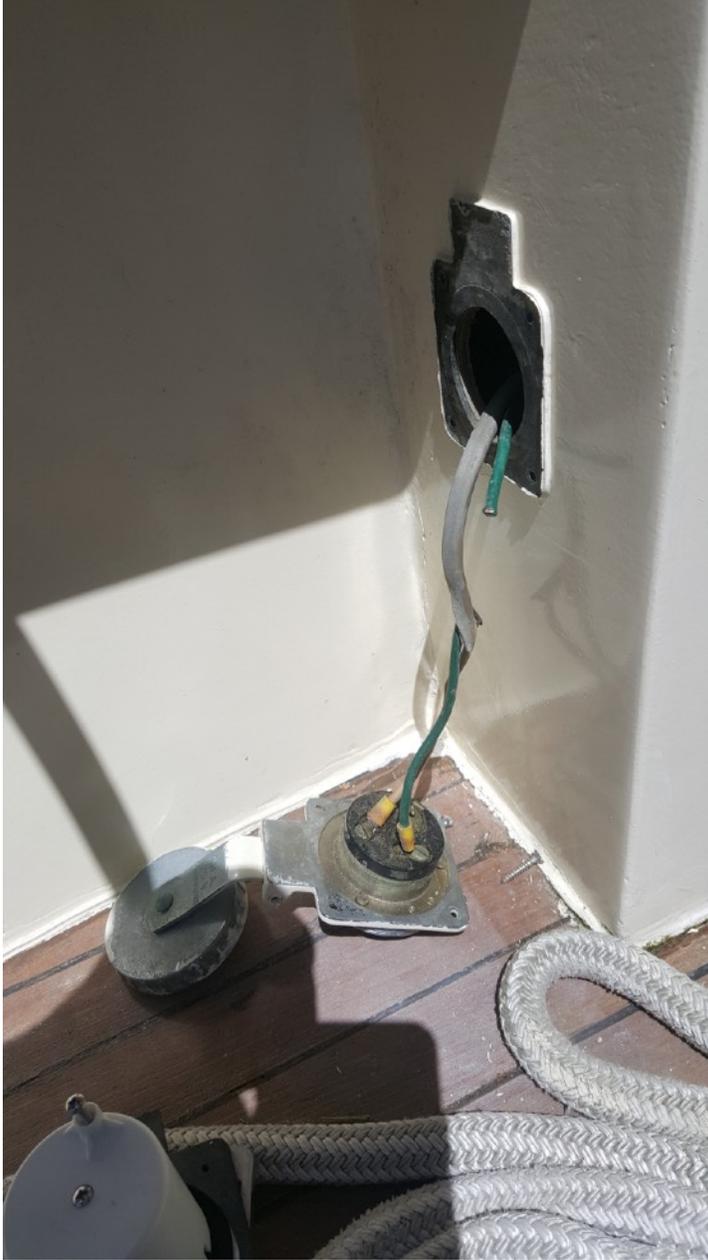
Upper left: old shore power removed; ground cut.

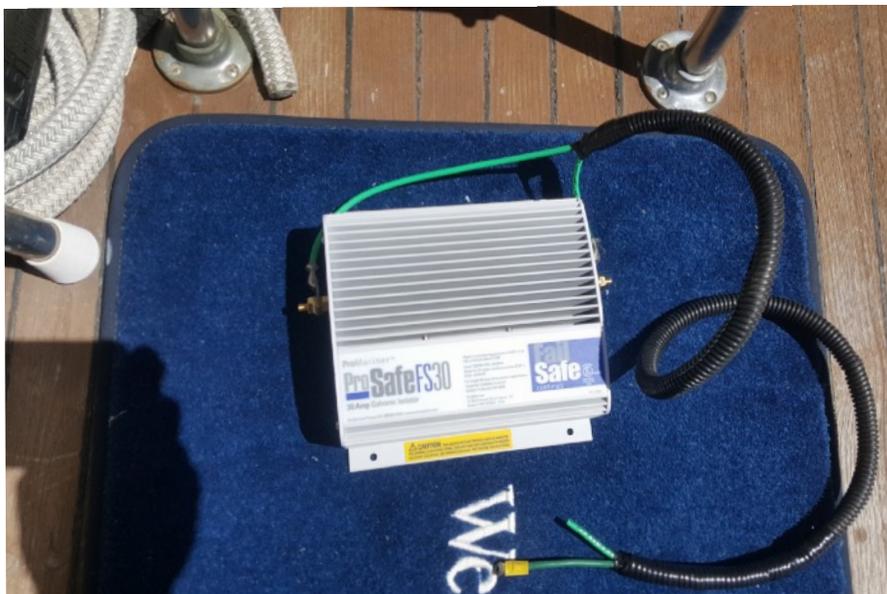
Lower left: galvanic isolator with 2 ground wires.
